Re: Administrative Order CWA-02-2011-3046
Village of Northport
SPDES Permit No. NYR20A303

**MS4 Inspection Report/Village of Northport (NYR20A303)–
June 20, 28 and 29, 2011**

MS4 Compliance Evaluation Inspection: Village of Northport
SPDES Permit No.: NYR20A303

Inspection Dates: June 20, 28, 29, 2011

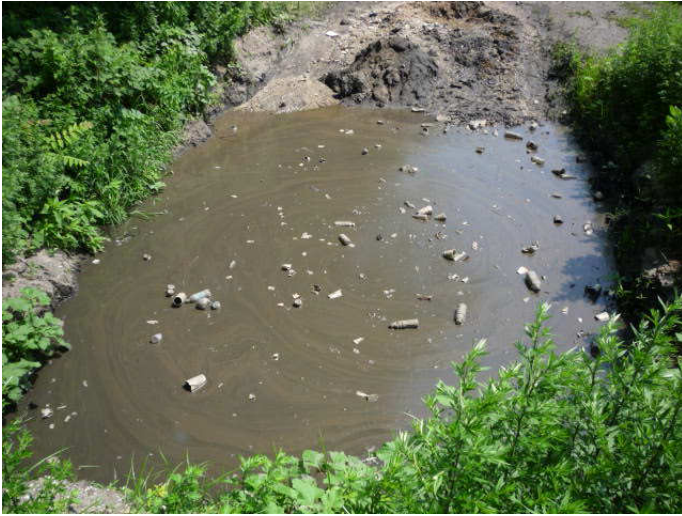
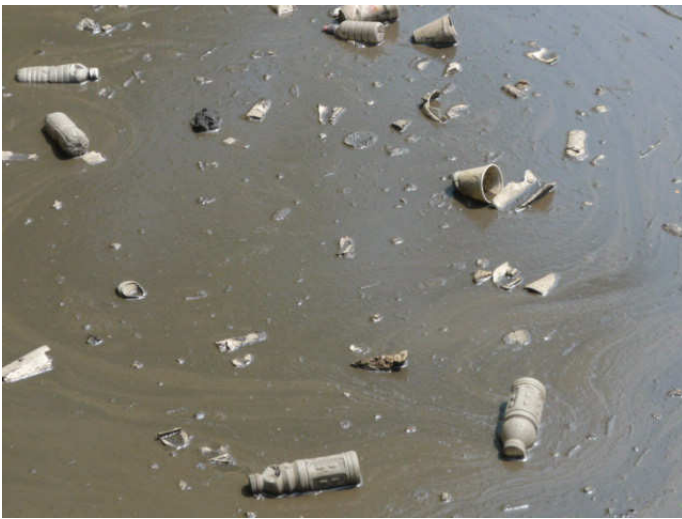
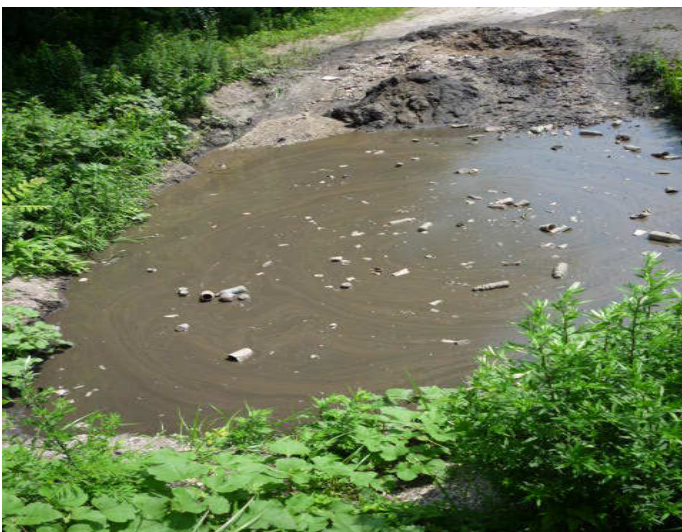
Steer's Park: This was an old pistol range. It is now Village owned and used for recreation and Village storage. Along one side of the recreation area was the pit that receives dumps from the vacuum truck. This pit is wider than it is deep and the oily fluid seeps into the ground. When it's dry the solids are scooped out and brought to the landfill. There were some piles for composting that are brought to Islip. Pictures at this location 179-181.

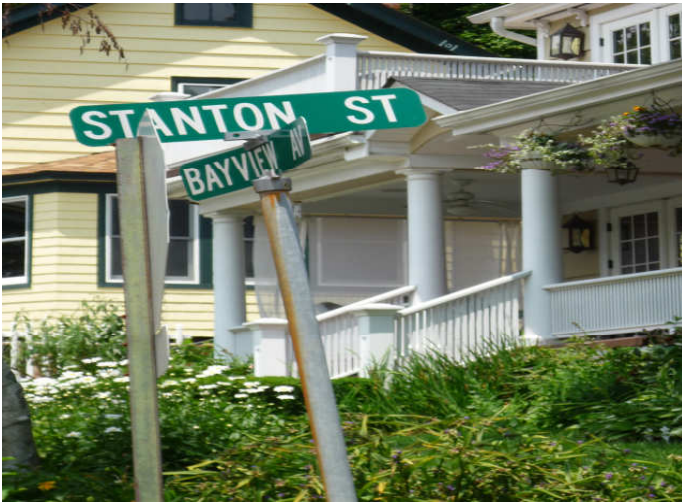
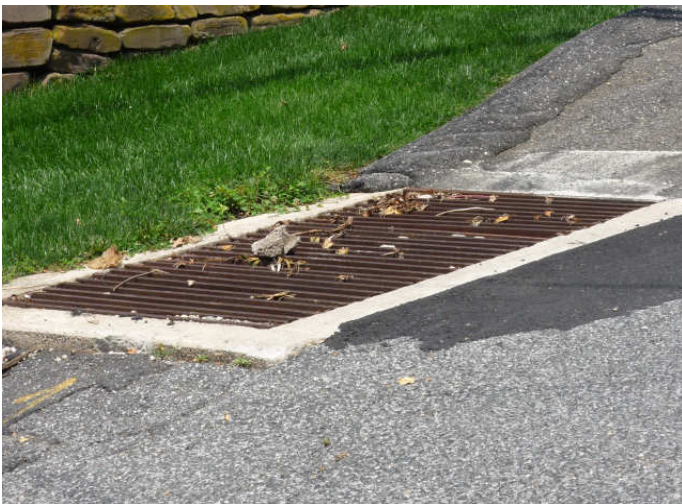
Stanton Street and Bayview Avenue: Catch basin, drop box (pictures 186-188) and manhole at this location. We smelled sewage at this location and had the manhole opened (picture 192). We observed sewage in the stormwater pipe. We also observed an extra pipe (private residence taped in).

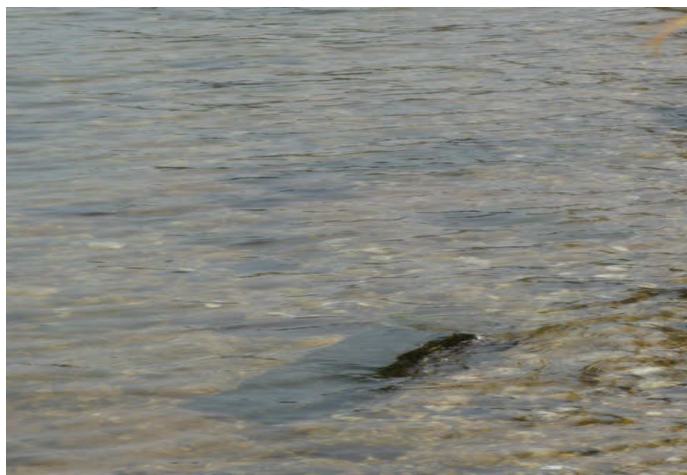
We then went through a, nearby house #91 to get access to the beach to view the outfall pipe (pictures 189-191). The concrete outfall pipe was flowing.

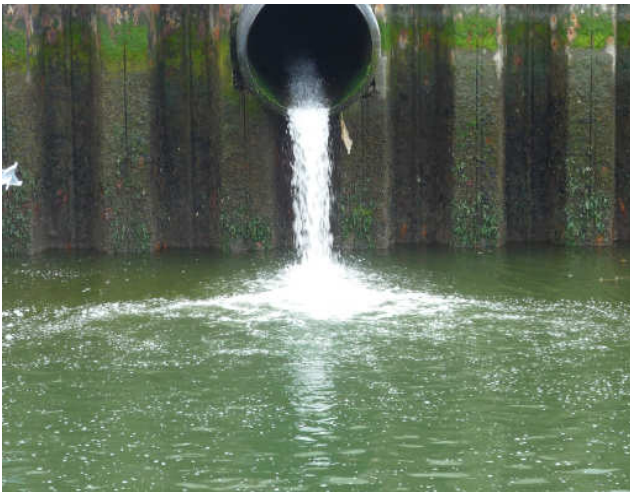
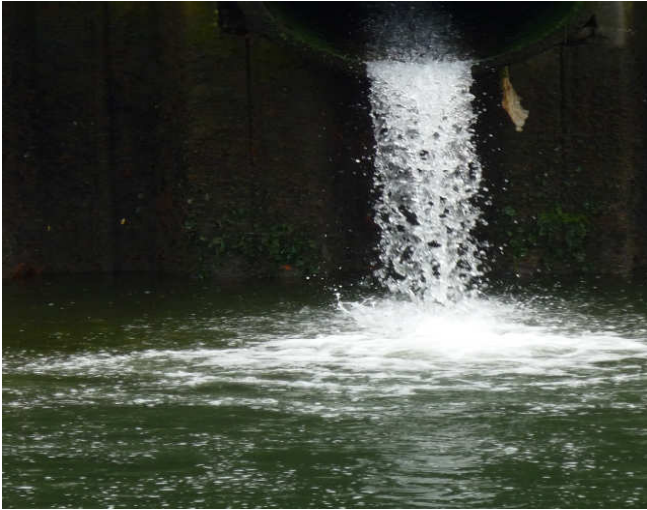
South wall: the second pipe at this location was a 36" outfall. We observed grease, suds and bubbles in the water. (pictures 196-198)

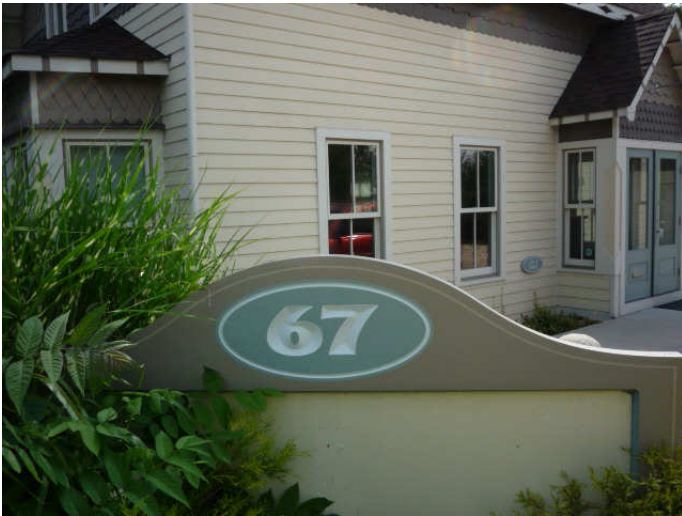
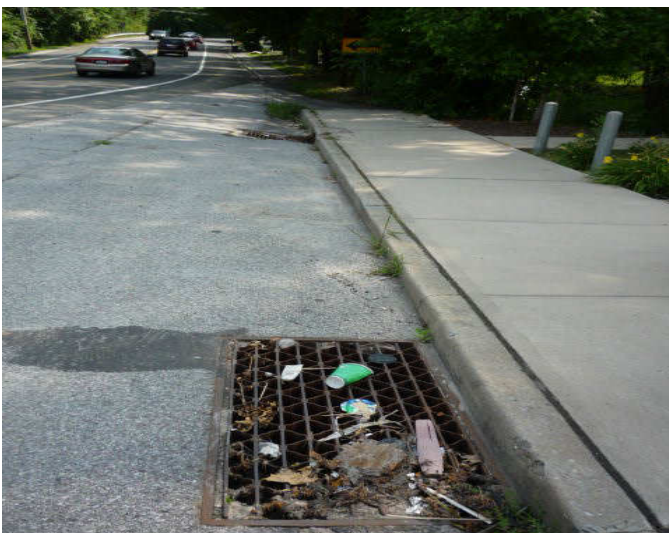
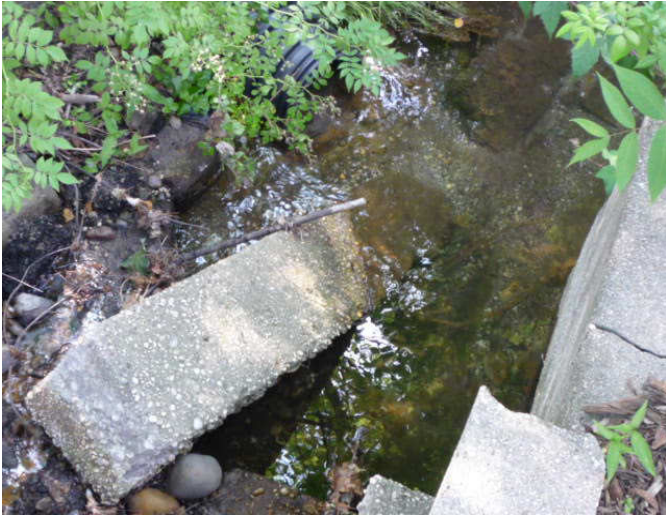
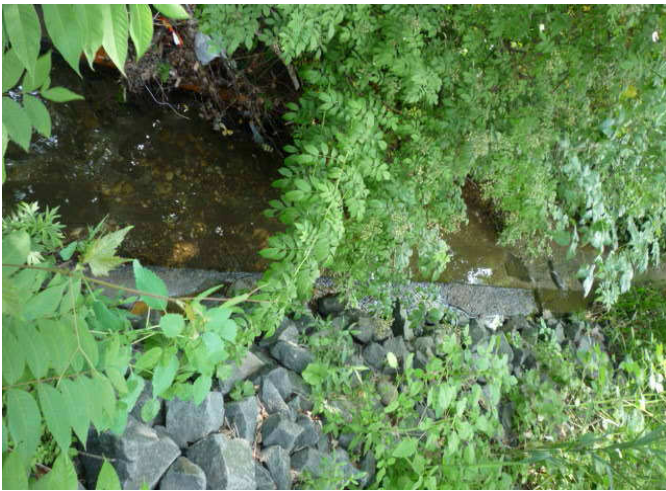
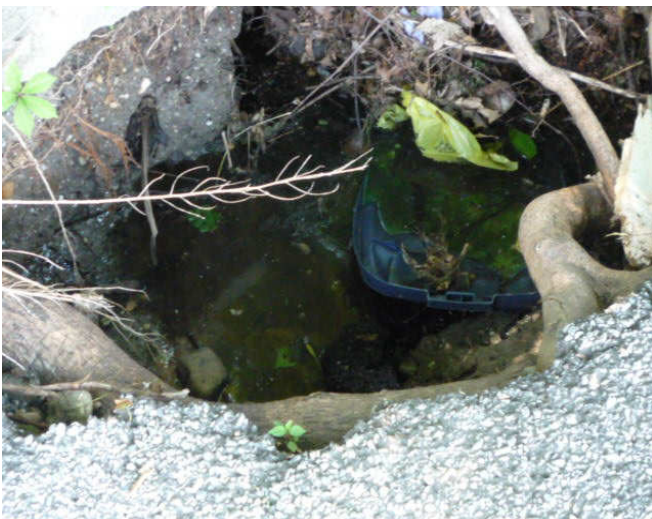
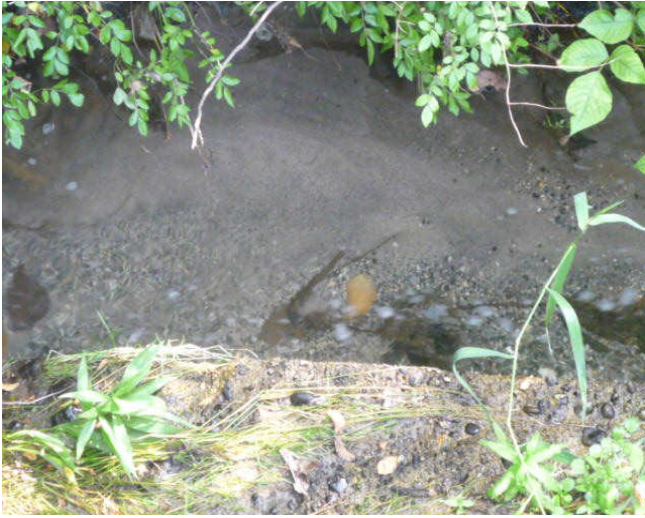
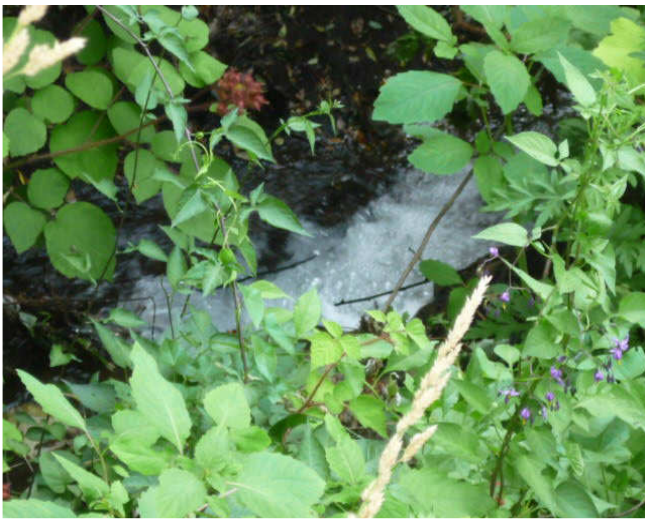
#67 25A outside of the marina: The catch basin was full to the top. There was a concrete structure adjacent to this property (Village drop box). On the other side of the property the tar was caving in above a 12" corrugated plastic pipe (pictures 199-205).

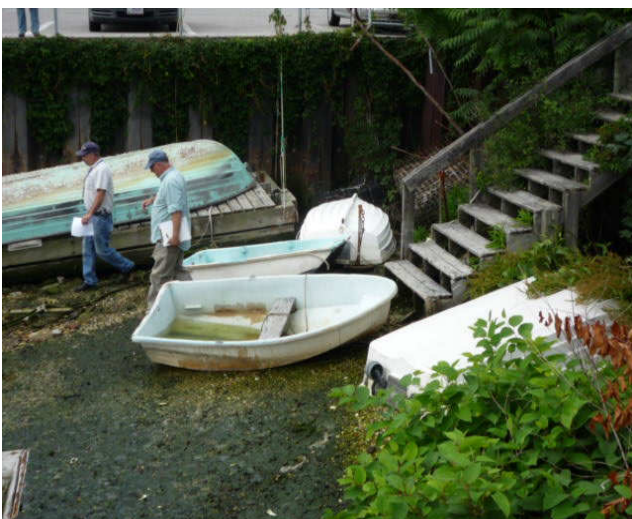
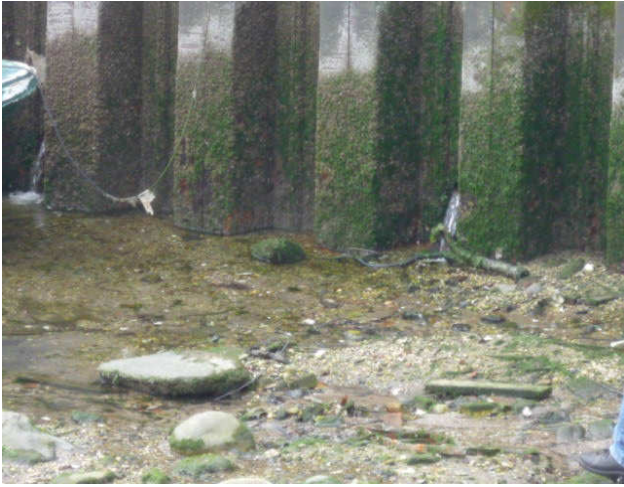
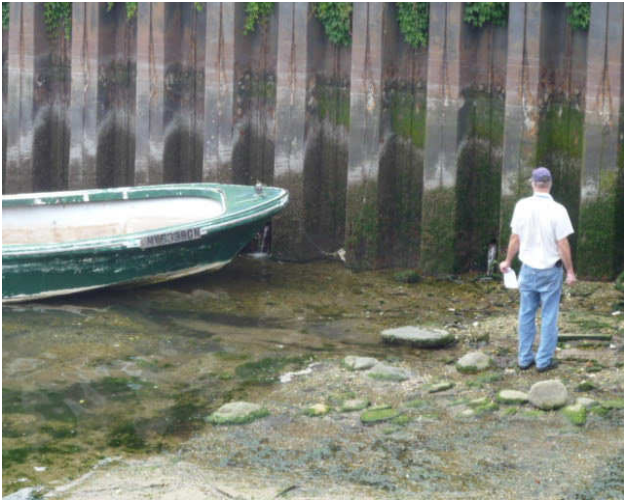
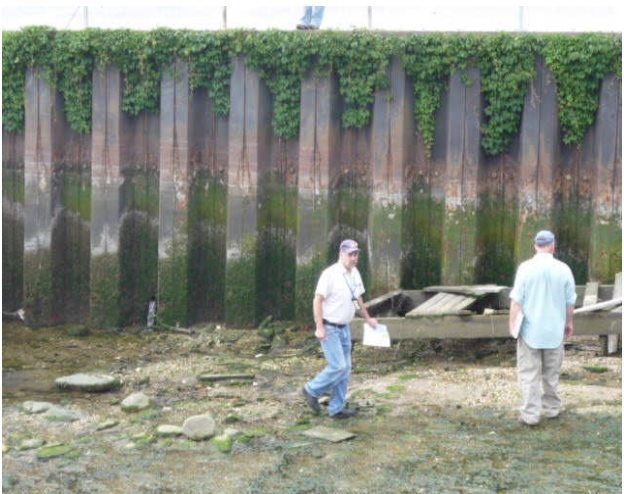
Woodbine Marina Parking: At the end of 5th Avenue and Woodbine Road there were four outfalls, three weeper holes for the parking area and one for the road (pictures 206-209).

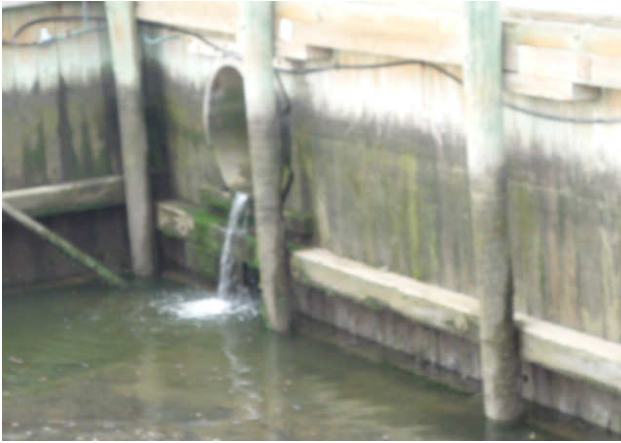
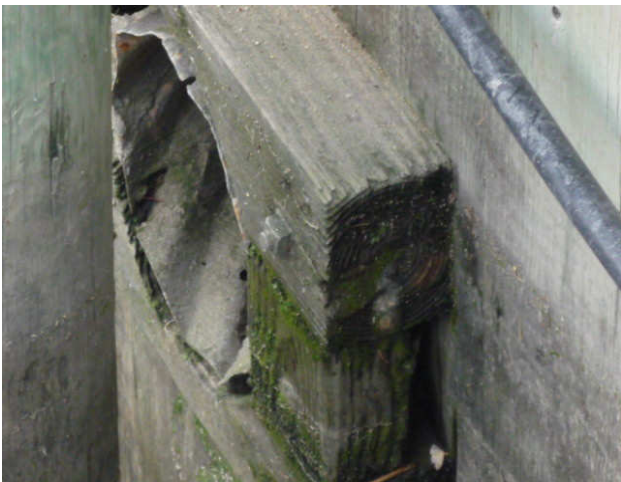
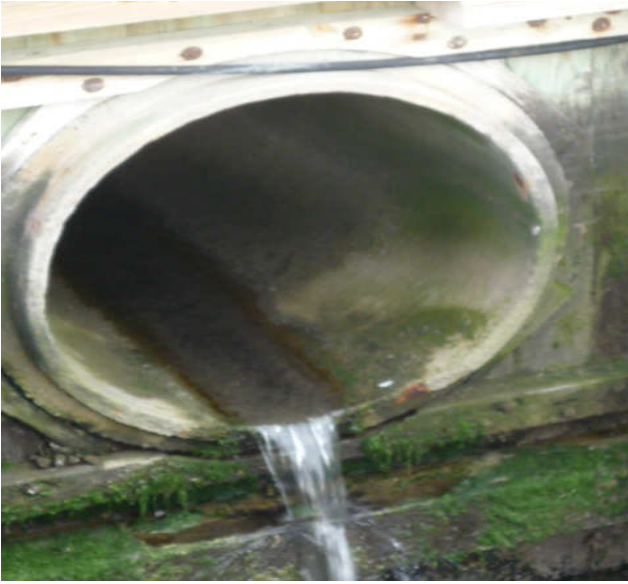
End of Main Street Park on North side of inlet: There was a 48" concrete pipe, flowing and a 12" corrugated metal pipe that was dry (pictures 210-213).
